Appendix G : Case Studies

Case Study 1 – Manufactured Home

Unit Type: Single-Wide Manufactured Home
Client Address: Wilmington, New Hanover County, NC

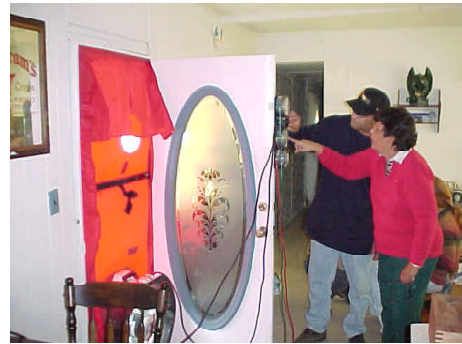
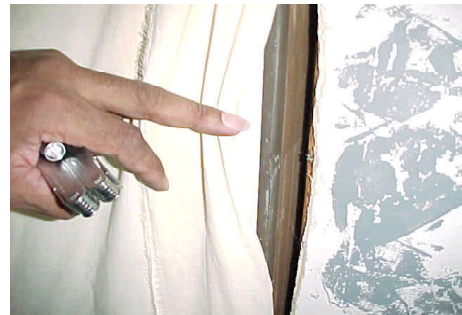
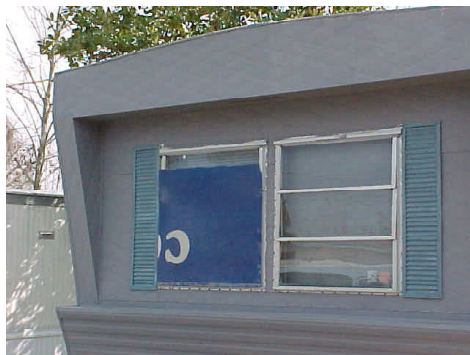
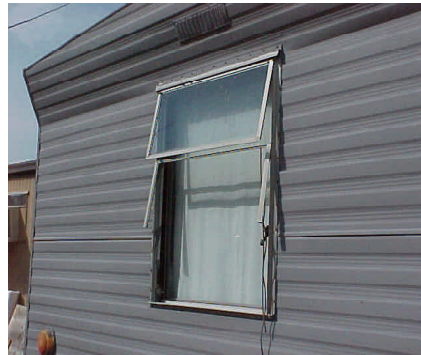
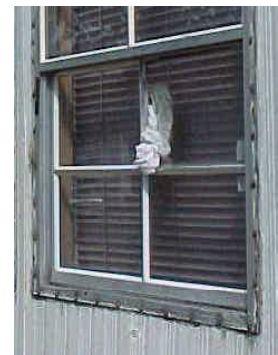
The blower door test results indicated the home had considerable air leakage. Leakage was found around the front door frame, where the original door had been replaced and around the second door that was improperly sized in a poorly fitted frame.

Broken and missing windows in the home also made a significant contribution to the poor blower door readings.

After completing the blower door test and furnace inspection, the Inspector decided that there were opportunities to use WAP funds to improve the energy efficiency of the home. Weatherization measures to stop air infiltration included the installation of doors and windows, and applying caulking, roof cement and

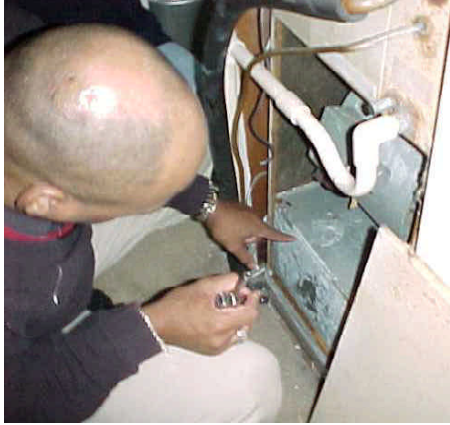
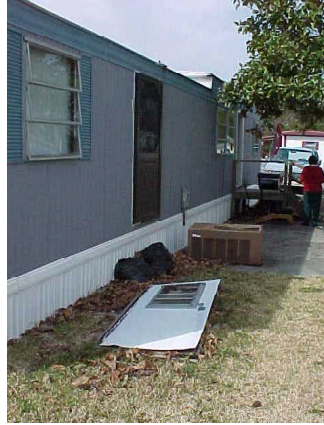
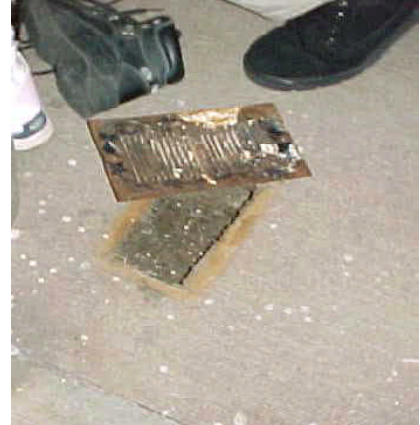
The Inspector then examined the furnace and interior heating systems. The furnace was located in a central cupboard, was improperly installed and not in working condition. There was considerable air leakage around the unit, as well as leakage through an unsealed flue from the original furnace. The heating ductwork was also in extremely poor condition. Many of the vents were rusted through, and the clients had taped cardboard over them to try to reduce the cold airflow. It was determined that these ducts could not be used.

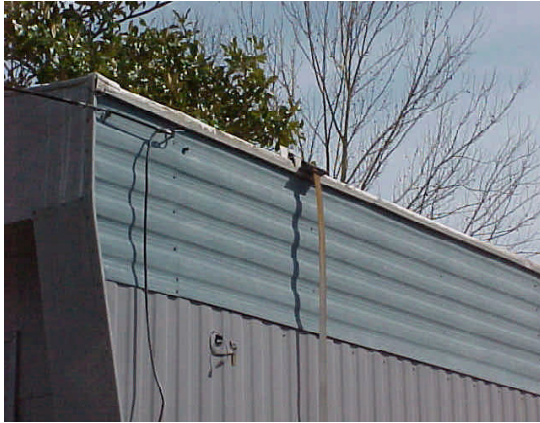
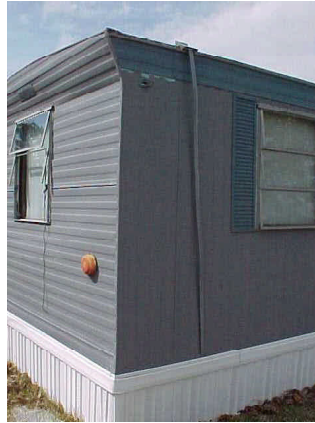
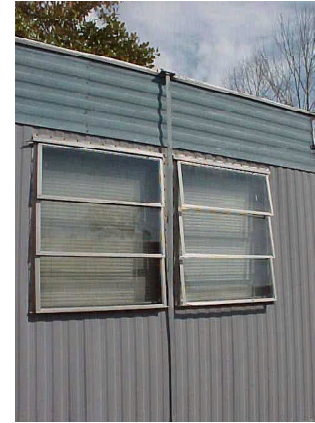
opportunities. The review focused on the higher risk wind hazard and included checking whether the mobile home was properly strapped and anchored. The home had standard “over the top” style straps, but a number of them were not adequately secured and were loose when pulled by hand.

The Inspector looked under the home to inspect the anchoring of the straps to the frame of the home and to the ground. The anchoring was adequate and used standard ground anchors that were appropriate for the conditions expected.

The exterior surface sheathing of the home was noted as being in fair condition. The doors and windows were noted as poor from a hazard mitigation perspective but would probably be replaced as part of the WAP. Most of the property was free and clear of debris. During the weatherization process excess building materials and debris would be removed from the property, in order to further reduce the potential for windborne debris.

- 2 Smoke & Carbon Monoxide alarms
- 1 Gas Safety Cut-Off Valve
- 4 2x4x8 Treated Lumber – for raising the gas tanks & interior furnace
- 2 1x4x10 Treated Lumber – for bracing the gas tanks & interior furnace
- 1 ¾” Plywood– for raising the gas tanks & interior furnace
- 1 Reattachment of Anchoring Straps

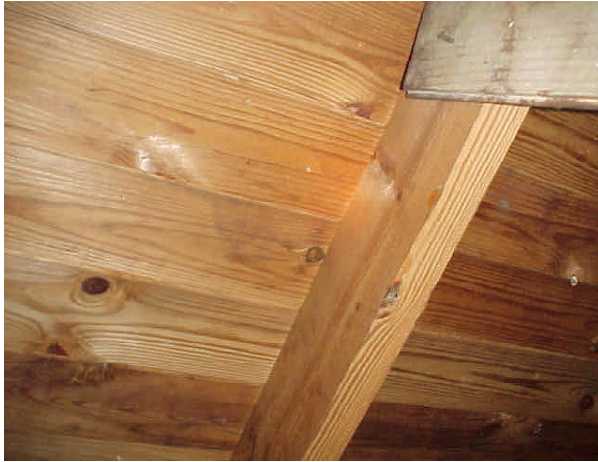
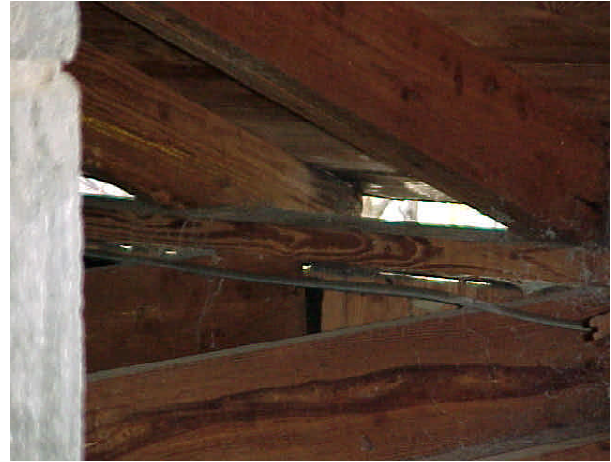
On arriving at the home, the Inspector introduced himself to the client and made sure she was aware of the purpose and goals of the WAP. Then he performed a basic review of the exterior and interior of the overall structure to ensure that the home conformed to program guidelines. The review included sketches and measurement of the home's layout. The unit was found to be structurally sound, except for a portion of the roof. Most of the roof sheathing consisted of wood boards running the length of the house and was found to be in fair condition. However, in one corner, the fascia board had rotted and part of the eave was missing, and, in another corner, the eave was badly damaged from rot and weathering. There was no insulation, and the missing eave created a large gap between the roof and wall.

The Inspector noted that this portion of the roof needed replacement. Although replacing the damaged portion of the roof would be more than the WAP alone could fund, weatherization by installing insulation would be useless without it. Also, from a risk mitigation standpoint, the Inspector realized that if the eave was not repaired, winds could blow up and into the roof space during a future hurricane. This action could accelerate the roof damage and potentially destroy the entire home. Therefore, it was in the best interests of the homeowner, WAP, and HI&M to repair the roof.

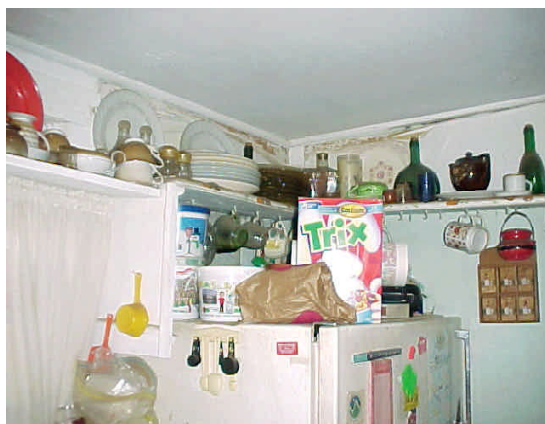
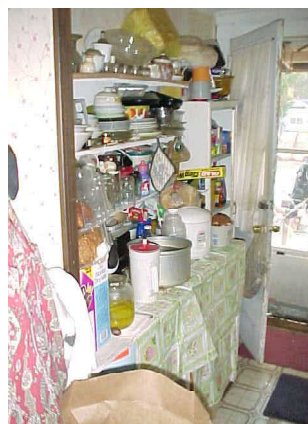
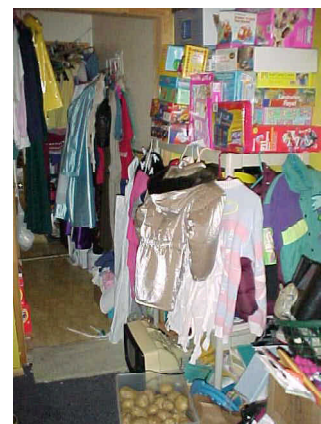
The Inspector also noted that there were no operating smoke or carbon monoxide detectors in the home. Although the risk of fire outside the home was reduced by a noticeable gap or fire break between homes and a lack of debris, the interior was at risk. The Inspector recommended installing smoke and carbon monoxide detectors, hardwired with a battery back-up.

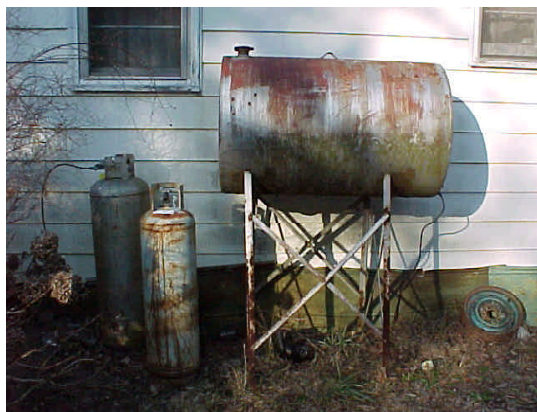
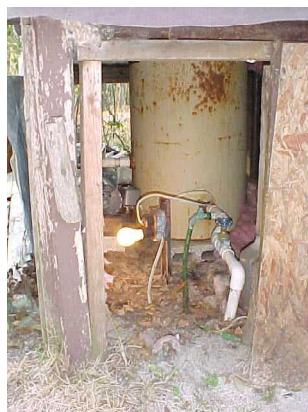
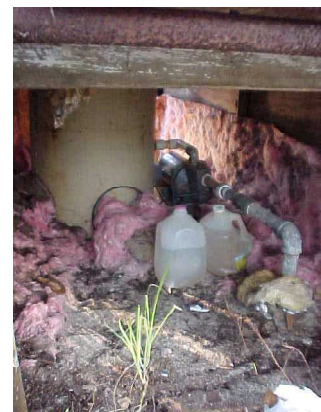
After examining the furnace and interior heating systems, the Inspector recommended installing a gas-fuelled heating system that would include gas tanks outside the home. Although this potential fire risk was insignificant, the Inspector saw the potential for leveraging his funds from HARRP, WAP, and HI&M. The Inspector recommended that while the certified gas installer was putting the heating system in place that he also install a gas safety cut-off valve on the fuel line. Doing so would reduce the risk of gas leakage if there were an interruption from wind, flood or earthquake. The tanks themselves should be strapped in place at a minimum and also elevated if there are enough funds left.

- Replace damaged or missing portion of roof
- Install Smoke and CO Alarms – hardwired with battery back-up
- Install Gas Safety Cut-Off Valve on fuel line
- Elevate and strap gas tanks
